Slope Stabilization Using Recycled Plastic Pins:

Phase II - Assessment in Varied Site Conditions

Final Report

Department of Civil and Environmental Engineering
University of Missouri - Columbia

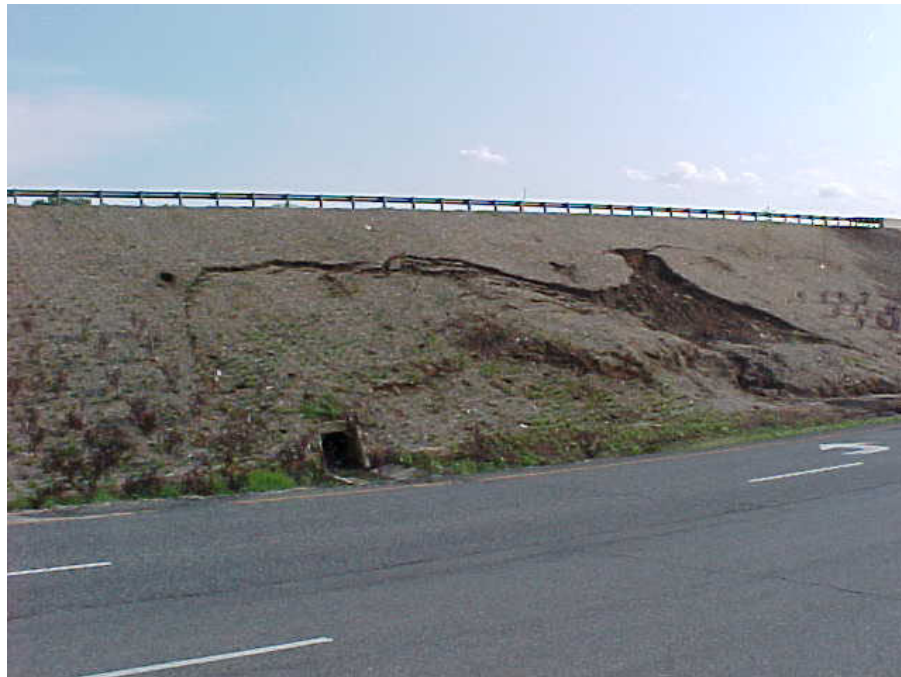
The I435-Wornall Road embankment is a zoned-fill embankment consisting of a 3- to 5-ft (0.9- to 1.5-m) thick surficial layer of mixed lean to fat clay with soft to medium consistency, overlying stiffer compacted clay shale. The embankment is approximately 32-ft (9.6-m) high with side slopes of 2.2H:1V (horizontal:vertical). The embankment had experienced surficial slides along the interface between the upper clay and the lower compacted clay shale on at least two occasions prior to being selected for stabilization as part of this project. Figure 5.2 shows a photograph of the site following the most recent slide event, which affected approximately 125-ft (38-m) of the embankment (measured parallel to I435). Prior to the most recent slide, extensive ornamental vegetation had been placed on the slope along with 4- to 6-in (100- to 150-mm) of gardening mulch as a part of a neighborhood beautification project. The most recent slide took out a large amount of this vegetation and caused much of the gardening mulch to become mixed with the surficial soils.

Figure 5.2 Photograph of most recent slide at I435-Wornall Road test site, June 20, 2001.

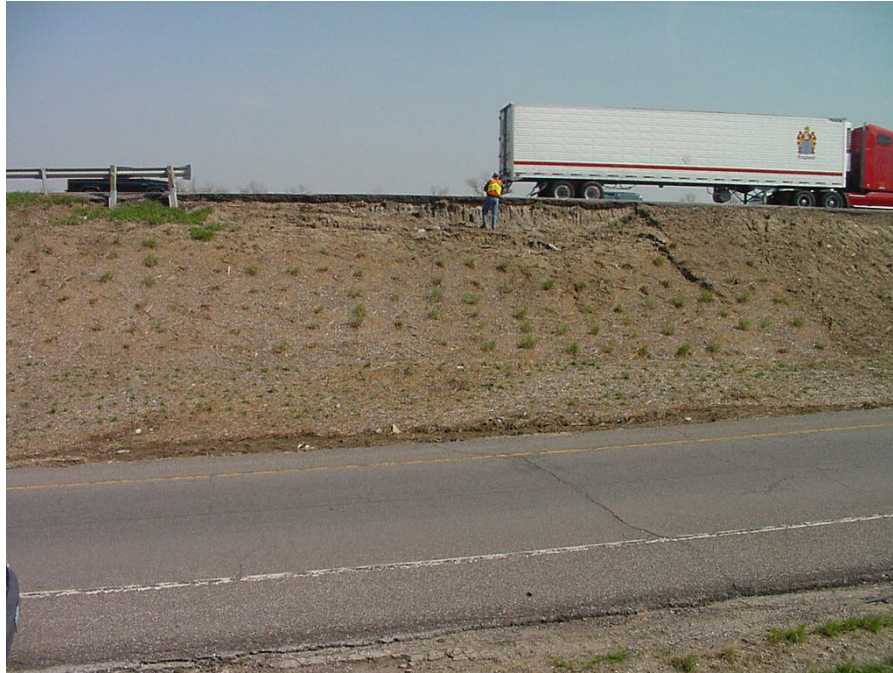
Figure 5.4 Photograph of the I435-Holmes Road site prior to stabilization.

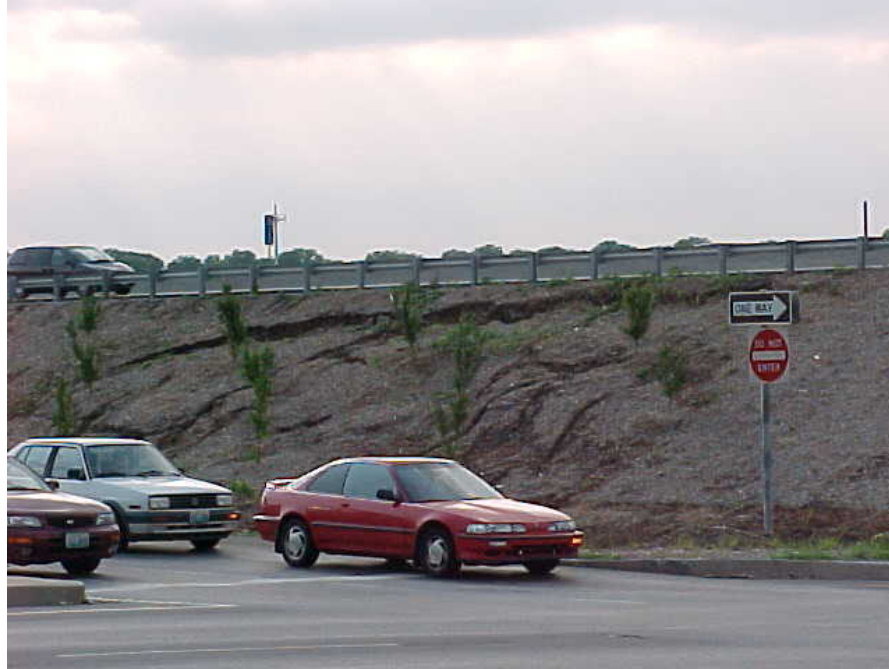
Figure 5.5 Photograph of the I435 Control Slide prior to being regraded for use as a control section.

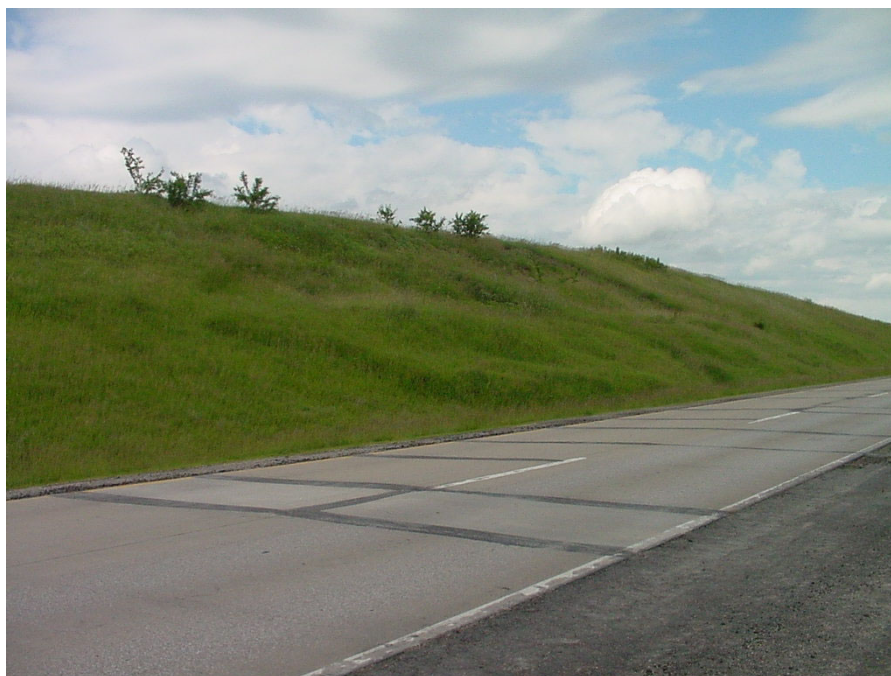
Figure 6.2 Photograph of US36-Stewartsville site taken after the recent slide at the site.

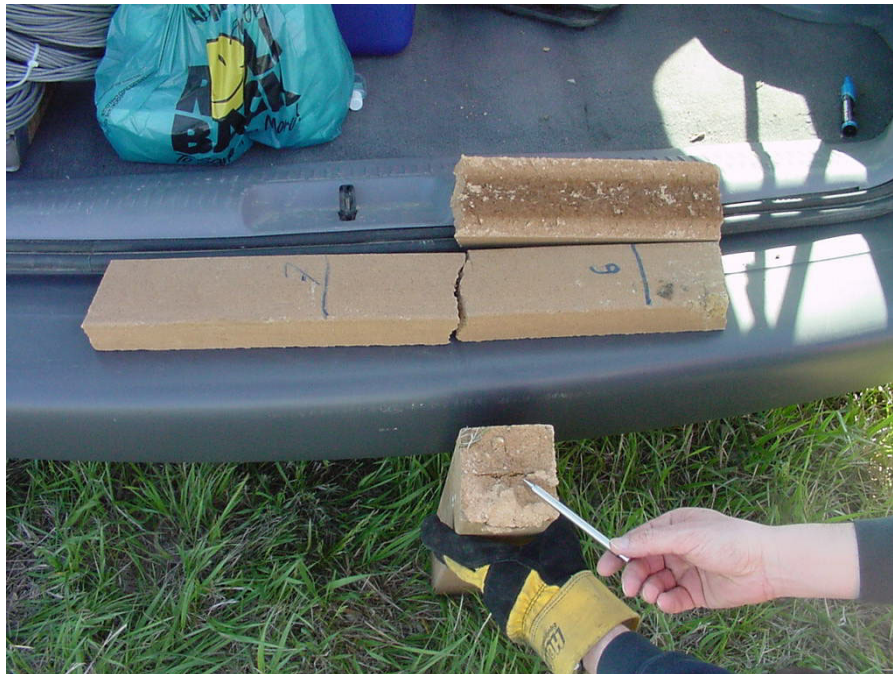
Figure 6.7 Photographs of defective recycled plastic members damaged during installation.

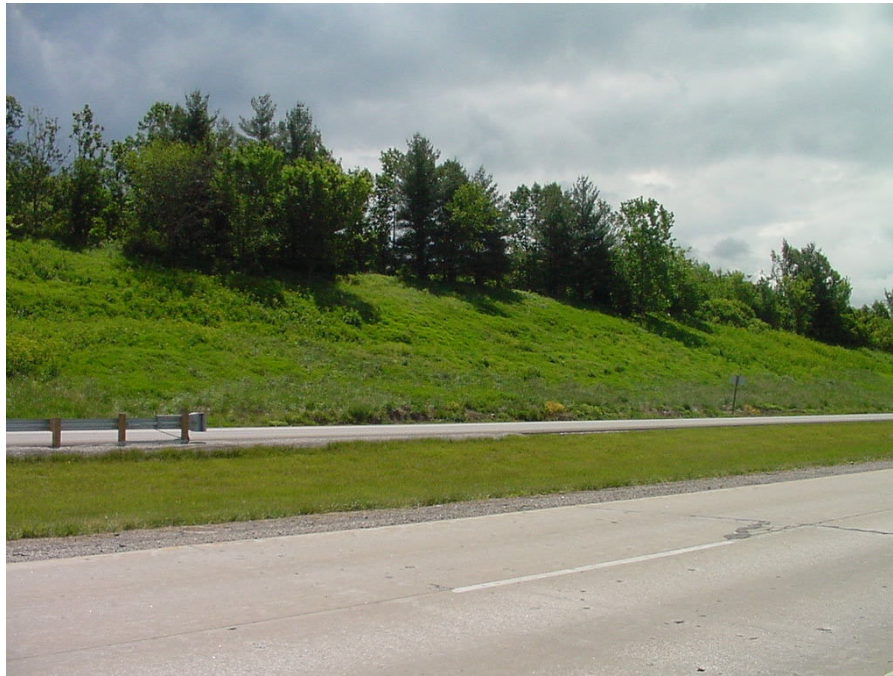
Figure 8.2 Photograph of US54-Fulton slope following most recent slide event.
